Twenty-Fourth DoD Explosives Safety Seminar St. Louis, Missouri

VENTED BOMB TESTS TO CHARACTERIZE PROPELLANT AND COMBUSTIBLE CASE EXTINGUISHMENT

by C. James Dahn Bernadette N. Reyes & Abdollah Kashani

Safety Consulting Engineers, Inc. Rosemont, Illinois 60018

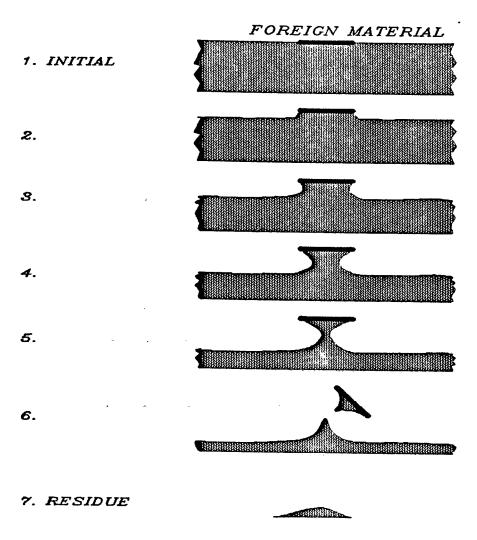
Figure 3. Residue Formation due to foreign material impeding flame front of propellant burn.

The most likely causal factor indicated by the testing was the presence of a foreign material (such as masking tape or aluminized duct tape) which interrupted the flame between the propellant and the interior combustible case wall. Refer to Figure 3 showing the progression of material consumption during the firing sequence. The delay in flame propagation, which resulted in the residue, could also have been caused by an uneven ignition of the propellant.
